Retrofitting NZ houses for energy efficiency and comfort

Bob Lloyd & Maria Callau

A research project by
the Energy Management Group
Physics Department - University of Otago
Dunedin

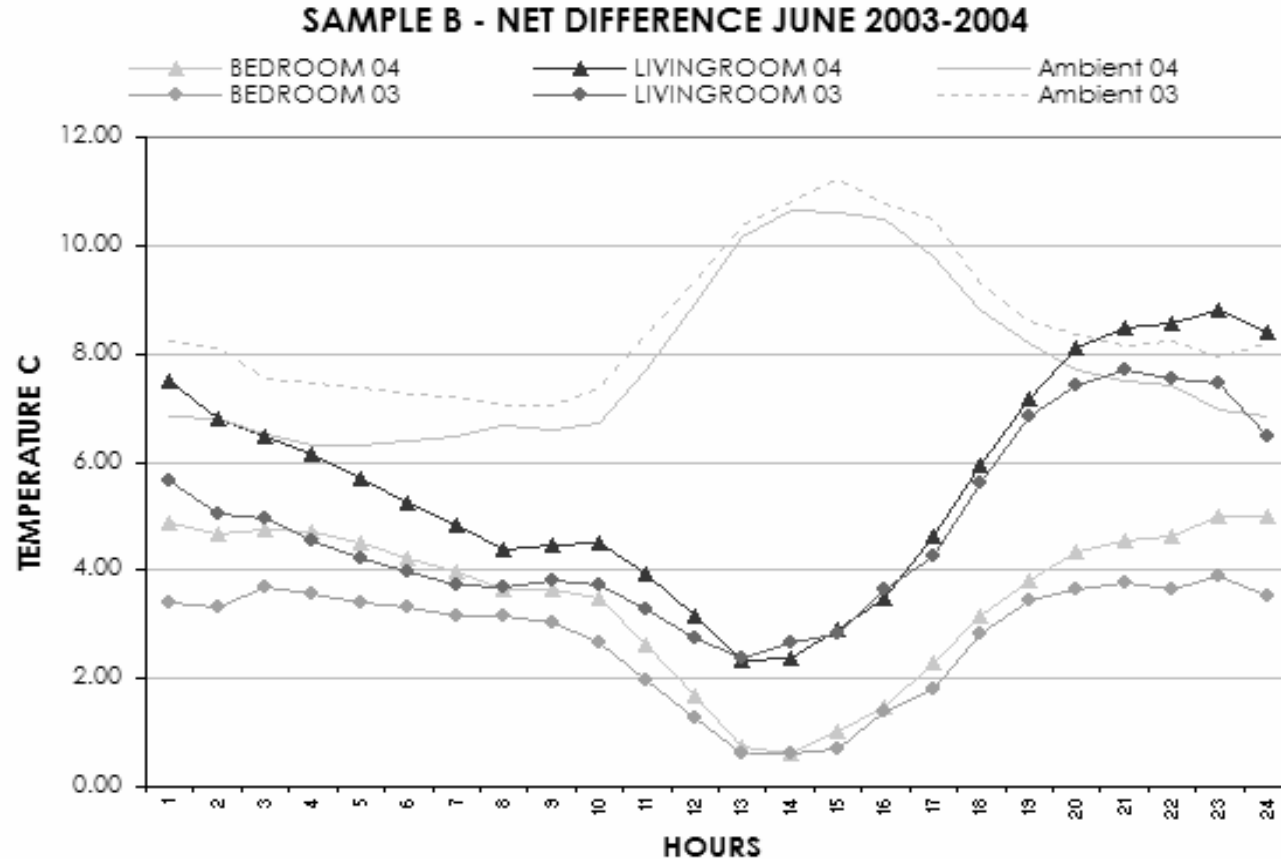
Net Temp Differences - June

- Higher net differences were achieved in living areas after heating was applied to these houses after upgrading
- 5% improvement in the number of hours above 12°C in June

- Low indoor temperatures predominated in winter... $<12^{\circ}\text{C}$ for 48% of the time during winter
- Minimum temperatures between 5 and 5.4°C (sample averages)
- Some improvement was found in net temperature difference after heating is applied (0.4°C whole year & 0.6°C over winter months).

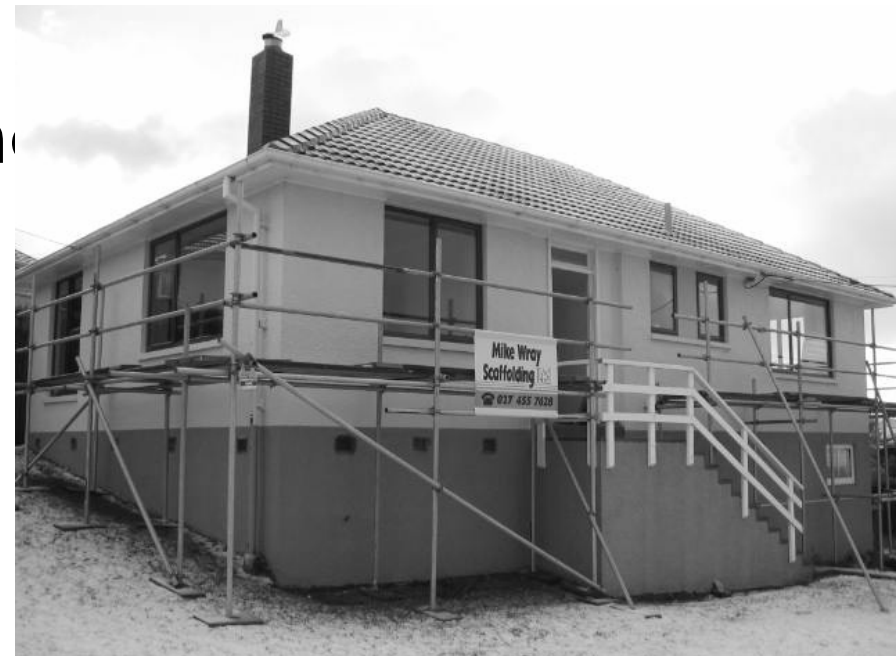
House 1

- Masonry veneer house:
 - concrete block
 - single glazed wooden frame
 - tiled roof
- Multi fuel burner in the living area
- **upgraded with the HNZC standard upgrade package**

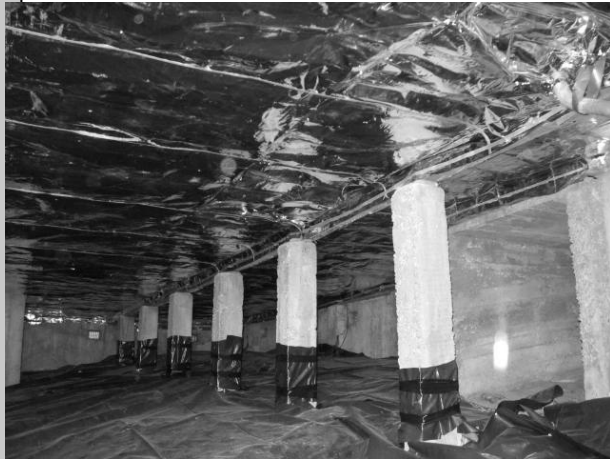
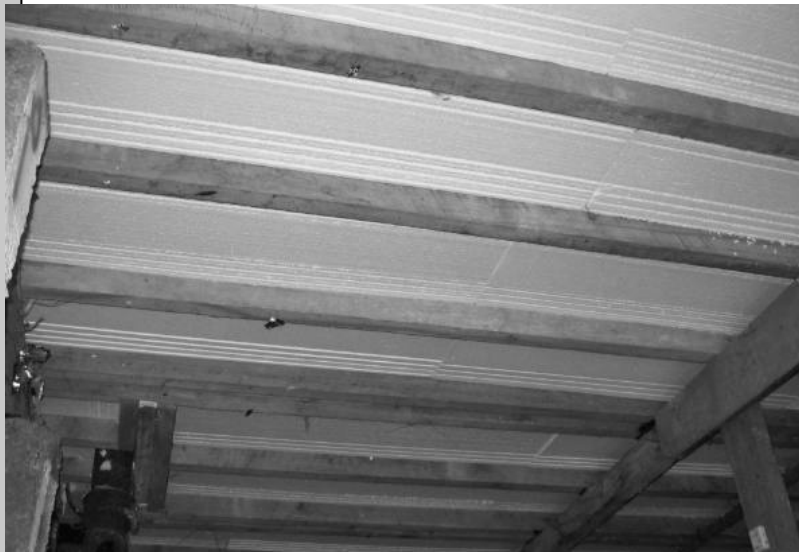
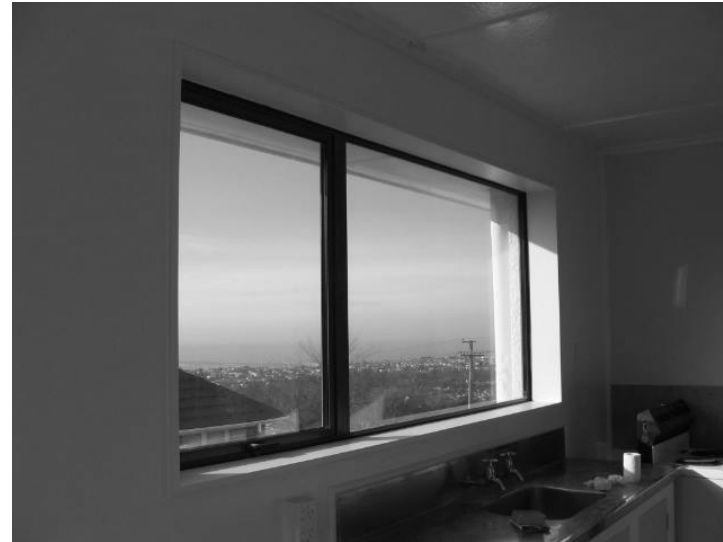
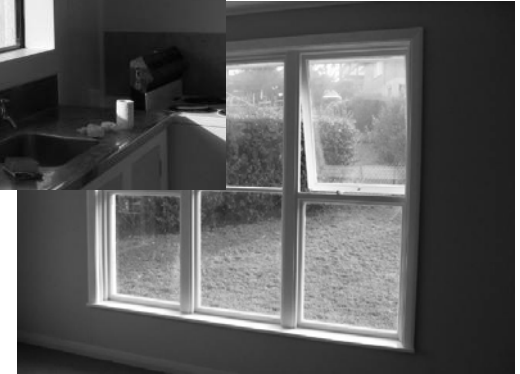
Underfloor & Windows

- Aluminium foil was replaced by EPS

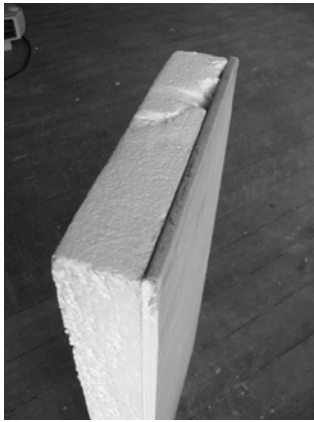
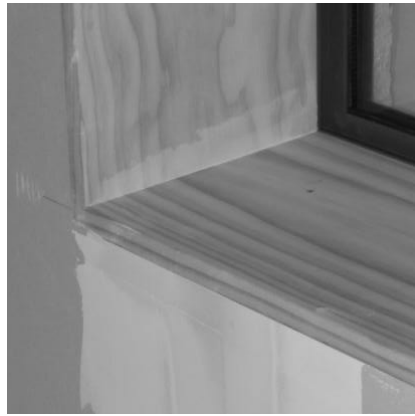
- Double glazed aluminum framed windows
- Drapes with pelmets

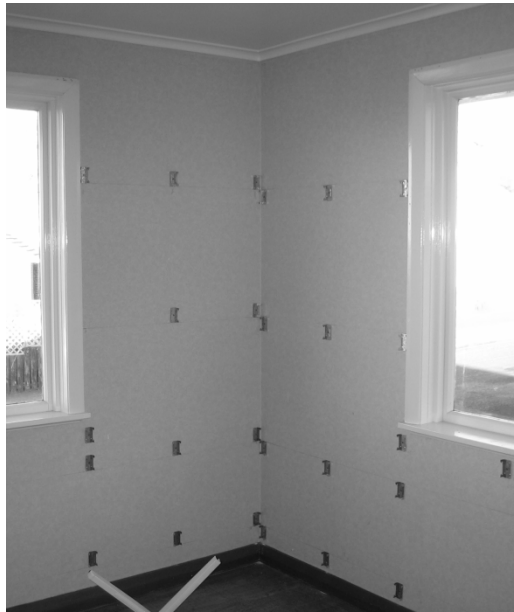
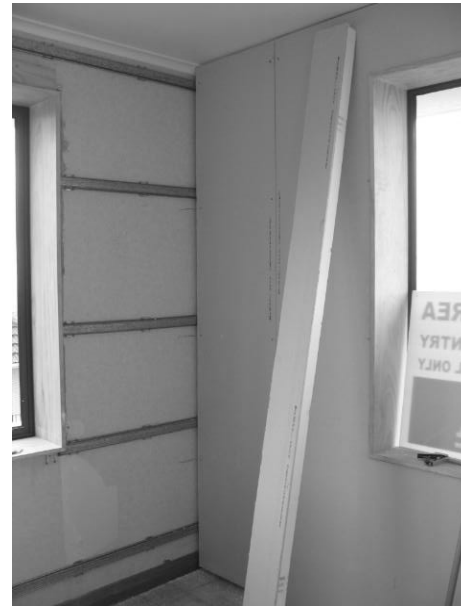
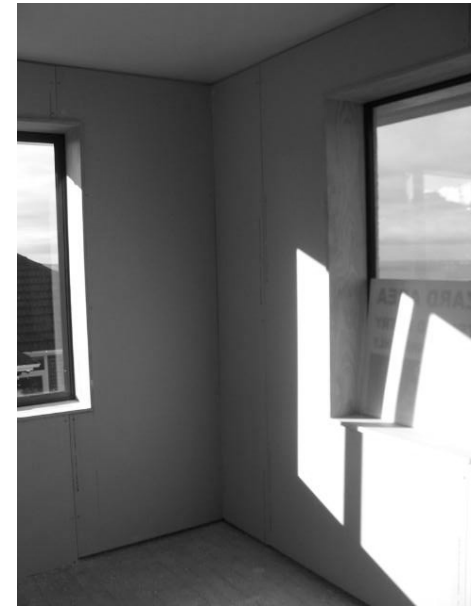
The Walls

- EPS & GIB on top of existing exterior walls.
- Window sill was done with new thickness required.

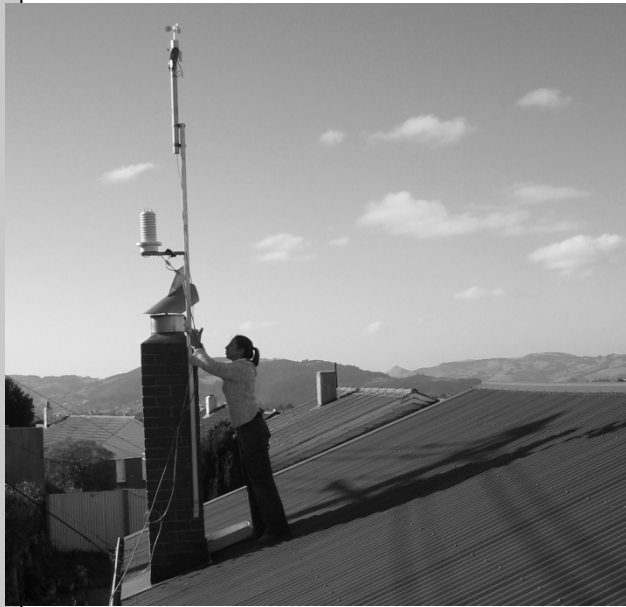
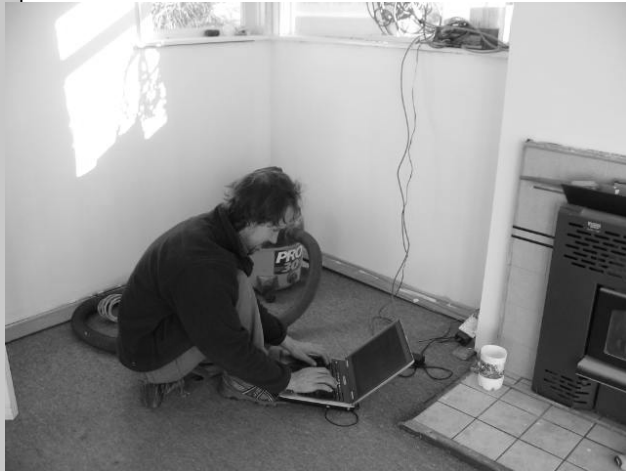
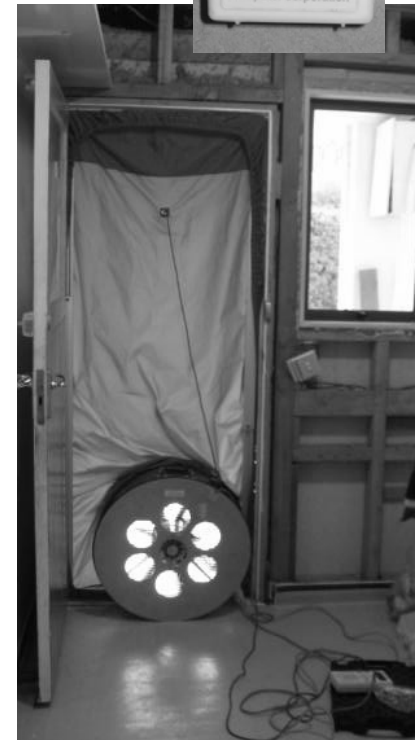
Monitoring: The equipment

- Indoor temperature and RH was monitored by placing data loggers in each room.
- A local weather station was installed in the roof.
- Data collected was downloaded to computer.
- Electric heaters were used to rise indoor temperatures.
- Fans were installed to generate internal air movement.
- A Blower door test was used to quantify the amount of ACH after each test.

- Specific thermal losses determined through the building envelope
- Houses were heated to achieve steady state then ΔT and P were recorded.
- Monitoring was done under the following conditions:
 - Night time (no solar gains)
 - Unoccupied (no internal gains / no evaporative gains)
 - ACH was known using a “blower door” test
 - Energy input was monitored
 - Envelope area was known
 - ΔT was monitored
